Low-Cost Shore Protection

Final Report on the Shoreline Erosion Control
Demonstration Program (Section 54)
1981

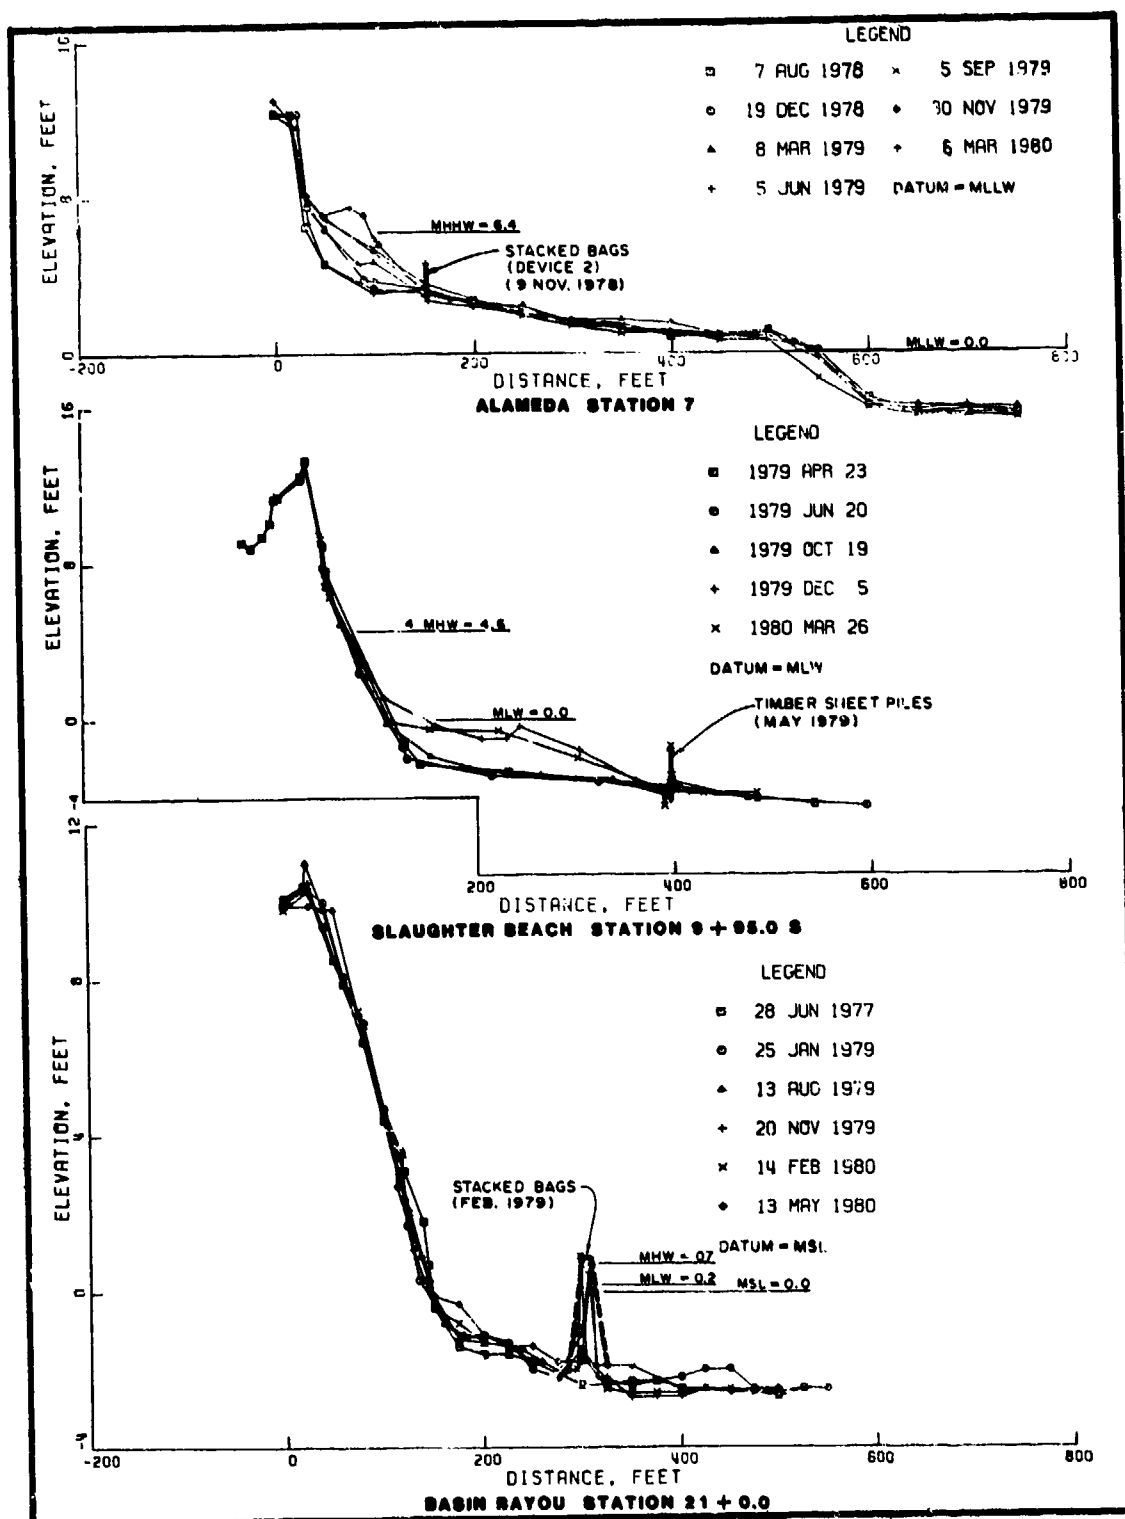
Figure 3-76. Profiles of stacked-bag sill, timber sheet-pile sill, and stacked-bag breakwater.

(2) Stacked Bags and Timber Sheet Piles. Profile analyses of these structures were done at Alameda, California; Slaughter Beach, Delaware; and Basin Bayou, Florida. These profiles are shown in Figure 3-76. A stacked-bag sill was demonstrated at Alameda, California, which consisted of sand-cement-filled bags made of nylon. This structure underwent some settlement, but proved to provide protection to the vegetated shoreline. The structure acted in conjunction with a groin. The profiles show accretion in lee of the sill, due to sand traveling over the groin being trapped by the sill.

All of these structures adequately maintained the beaches in their lee. The stacked bags at both Alameda and Basin Bayou suffered some damage, but this did not affect their performance appreciably.

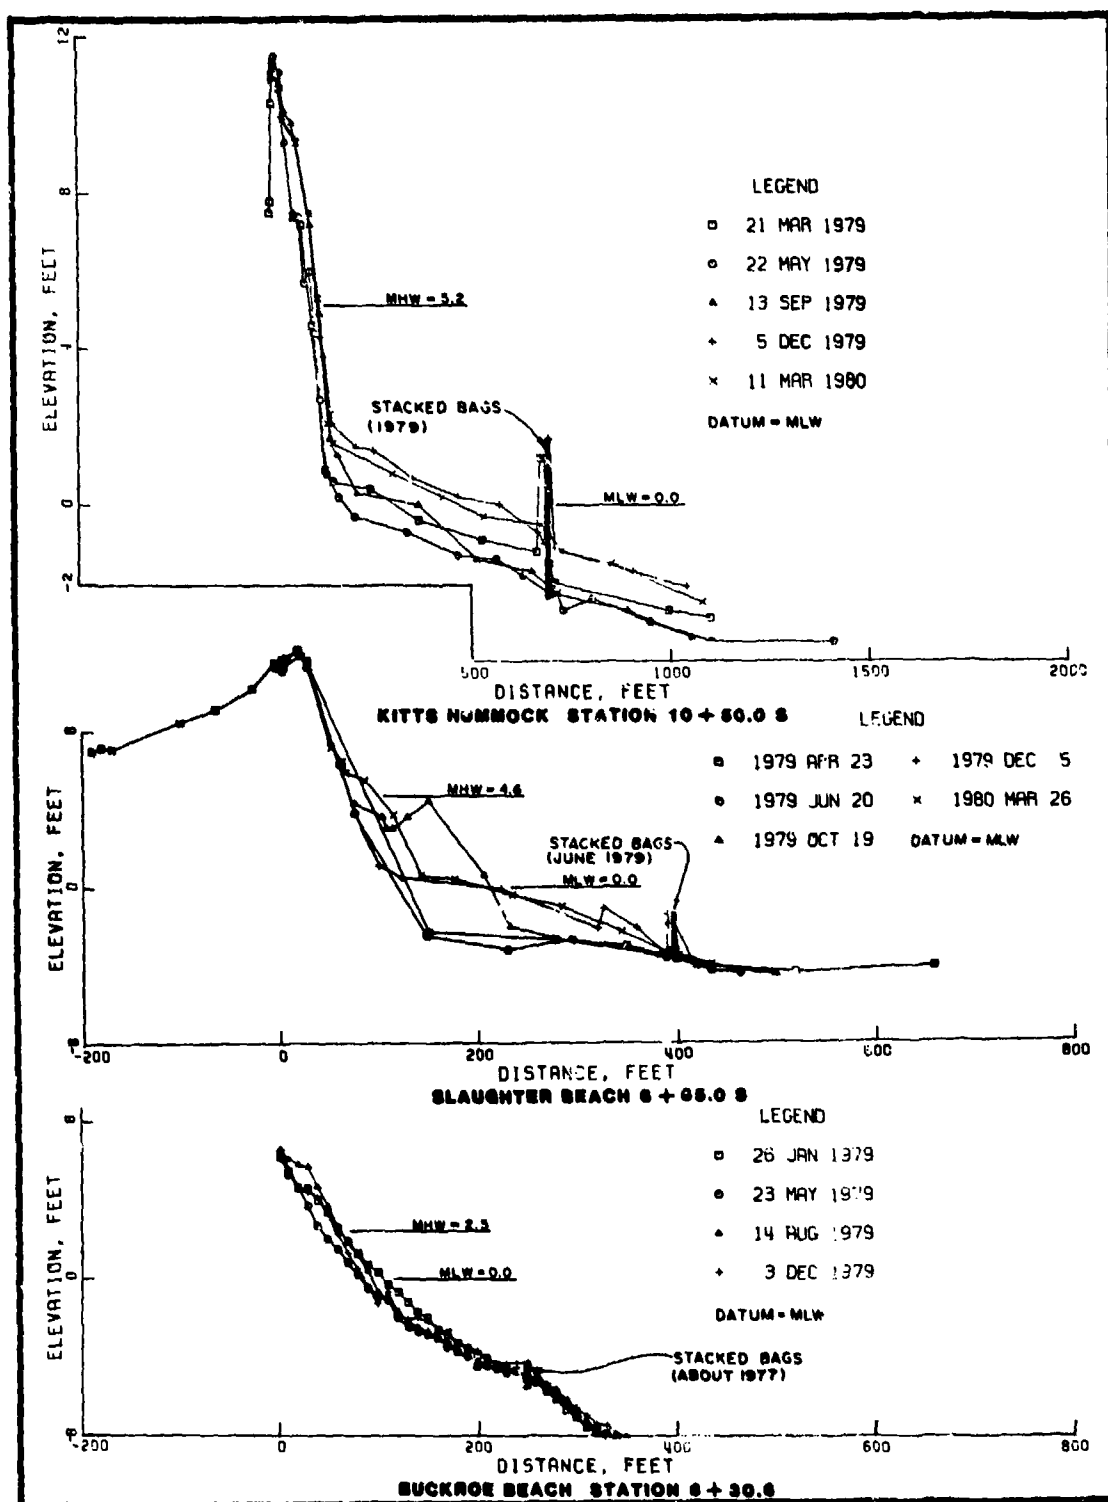
Figure 3-77. Profiles of stacked-bag sills.

(3) Stacked Bags. Profile analyses of stacked-bag breakwaters (sills) were done at Kitts Hummock, Delaware; Slaughter Beach, Delaware; and Buckroe Beach, Virginia. These profiles are shown in Figure 3-77.

At Kitts Hummock, the bags deteriorated somewhat, but the breakwater remained functionally effective. The profiles at this site show a progressive accretion in the lee of the breakwater.

The sandbag sill at Slaughter Beach performed reasonably well in retaining a perched beach, despite some misalignment of bags which occurred during the monitoring period. The profiles show that accretion was present behind the structure, particularly in the latter months of the monitoring period.

At Buckroe Beach, the sandbag sill underwent some slight movement and separation of bags. This sill was placed between flanking groins to contain a perched beach. The profiles show that this structure had little effect on the beach in its lee.

The structures at Kitts Hummock and Slaughter Beach performed well, the latter undergoing deterioration but still containing the perched beach.

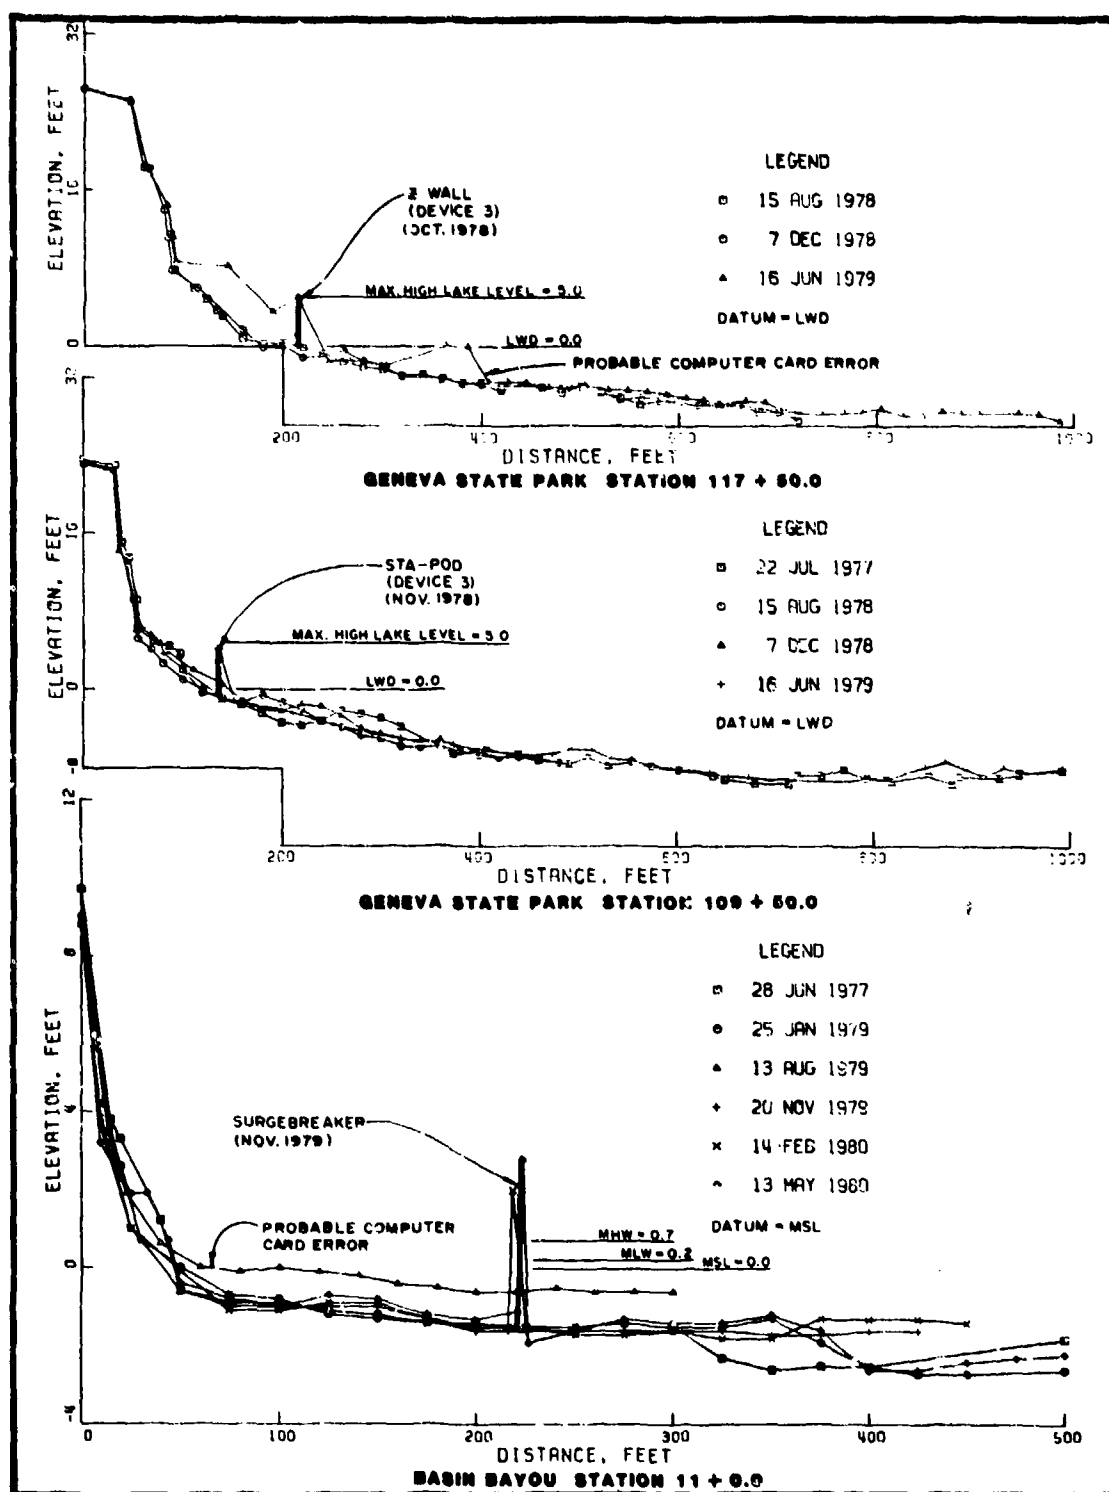
Figure 3-78. Profiles of Z-wall, Sta-pod, and Surgebreaker breakwaters.

(4) Z-Wall, Sta-Pods, and Surgebreaker. Profile analyses of Z-wall, Sta-pod, and Surgebreaker breakwaters were done at two sites--Geneva State Park, Ohio, and Basin Bayou, Florida. The profiles for these structures are shown in Figure 3-78.

The Z-wall breakwater was demonstrated at Geneva State Park. Panels of this structure were broken off due to nonuniform settlement. The profiles show that this structure, despite damage, was successful in trapping sand.

The Z-wall breakwater at Geneva State Park was the most successful in trapping sand, but is prone to structural damage. The Sta-pod device appeared to be the least successful.

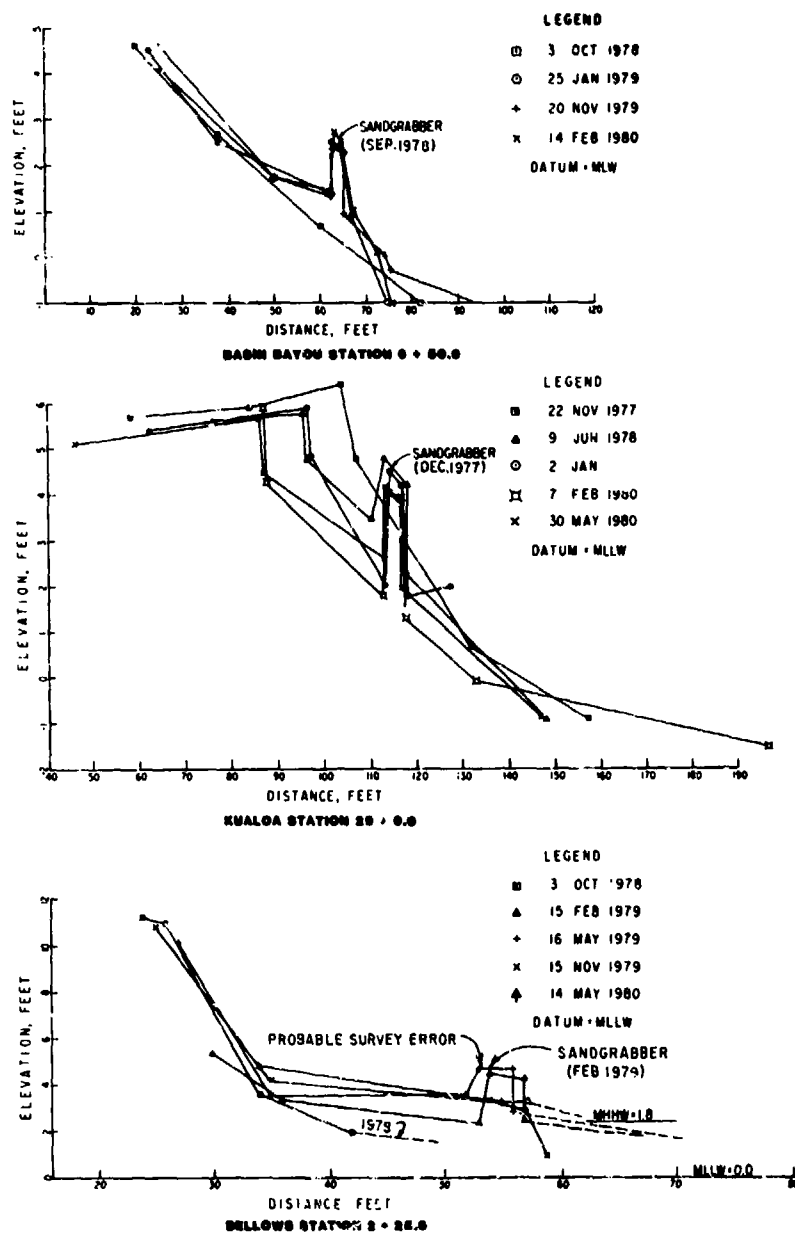
Figure 3-79. Profiles of Sandgrabbers.

Figure 3-79, which was put in Section III for comparison of similar devices shows a series of profiles through the sandgrabber. The profiles show the accretion and erosion trends and depict the uneven settlement of the structure.

(5) Sandgrabber. A profile analysis was done on Sandgrabbers at three sites--Basin Bayou, Florida; Kualoa, Hawaii; and Bellows Air Force Station, Hawaii. The profiles for these sites are shown in Figure 3-79. At Basin Bayou, the structure suffered some damage, attributed to erosion of sand from under the toe causing seaward rotation of the structure and block breakage. The profiles show that sand has been trapped by the structure, but variations in the sand level behind the structure has also been present.

The Sandgrabber at Kualoa, although structurally damaged, maintained its shape while settling throughout the monitoring period. Although the profiles do not show it clearly, the Sandgrabber trapped sand both in front of and behind the structure throughout the period, but in doing so, caused considerable downdrift erosion.

The Sandgrabber at Bellows Air Force Station also trapped sand at the beach in its immediate vicinity. This structure, like the other Sandgrabbers, also suffered from toe scour and subsequent nonuniform settlement. The accretion present at the Bellows Sandgrabber (shown in the profiles) was not to the detriment of adjacent beaches as at Kualoa. This was due to the predominantly onshore-offshore littoral transport at the site.

The profiles show that the Sandgrabbers all suffered from differential settlement due to toe scour. The Bellows Beach Sandgrabber appeared to be most successful in that it did not cause downdrift erosion.
